**DEPARTMENT OF TRANSPORTATION****DIVISION OF ENGINEERING SERVICES**

Contract #: 04-0120F4Cty: SF/ALA Rte: 80 PM: 13.2/13.9File #: 69.28**WELDING INSPECTION REPORT****Resident Engineer:**Siegenthaler, Peter**Address:** 333 Burma Road**City:** Oakland, CA 94607**Report No:** WIR-024110**Date Inspected:** 02-Jun-2011**Project Name:** SAS Superstructure**OSM Arrival Time:** 1900**Prime Contractor:** American Bridge/Fluor Enterprises, a JV**OSM Departure Time:** 700**Contractor:** Zhenhua Port Machinery Company, Ltd (ZPMC), Changxing Island **Location:** Shanghai, China

Visual Inspections of segment 13AE PP119 +1500mm to PP120 on the bikepath side upper surfaces

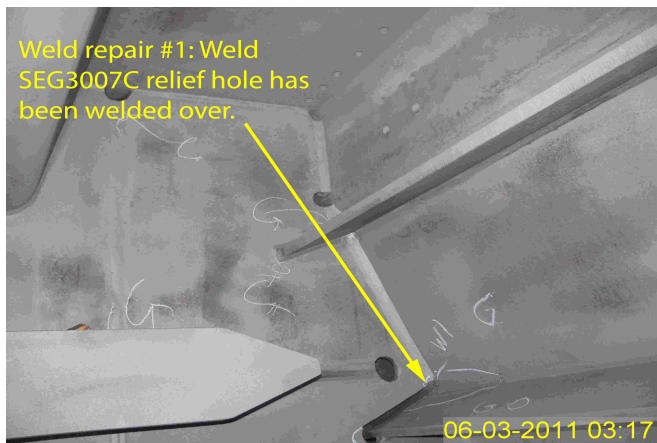
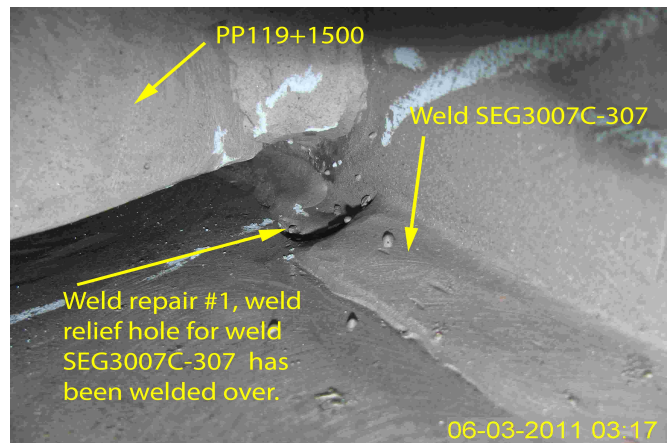
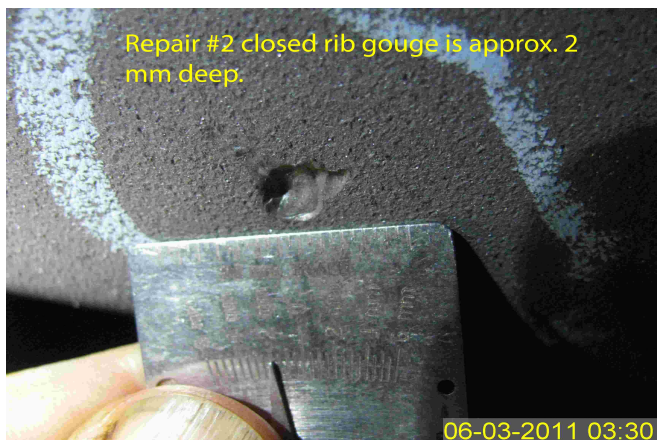
of the steel surfaces. This QA Inspector along with one other QA Inspector performed random visual inspections of these areas and observed the following items appear to require weld repairs. This QA Inspector observed item #1 and #2 as listed below and the other areas were identified by another QA Inspector and American Bridge (ABF) Inspectors. The following areas were marked on applicable drawings which were forwarded to dayshift QA Inspectors for tracking of repairs. See the photographs below for additional information.

1. The weld relief hole at the termination of stiffener plate weld SEG3007C-307 where it terminates at SEG3007G, panel point PP119+1500 has been welded over. Note: this might not be a weld repair, but it may require a significant effort to achieve a satisfactory weld relief hole and proper weld termination.
2. Closed Rib base material arc gouge on deck plate DP3080A second closed rib from weld SEG3007G-007 towards weld SEG3007G-010. This gouge is located approximately 900 mm from SEG3007G @ PP119 +1500 mm, towards SEG3007E. Depth of the gouge is approximately 2.0 mm.
3. Base material arc gouge between SEG3007E and SEG3007C on LD3026A inside the lifting lug closest to SEG3007E. Depth of the gouge is approximately 4.0 mm.
4. ABF marked "WELD" and taped over DP3080A closed rib closest to weld SEG3007G-010, where it intersects SEG3007G, PP119+1500.
